Theodossopoulos, D 2015, 'Death and life of churches in 18th century Scotland', Paper presented at Reading Architecture Across the Arts and Humanities, Stirling, United Kingdom, 5/12/15 - 6/12/15.

Death and life of churches in 18th century Scotland

Dimitris Theodossopoulos, ESALA, Un. of Edinburgh

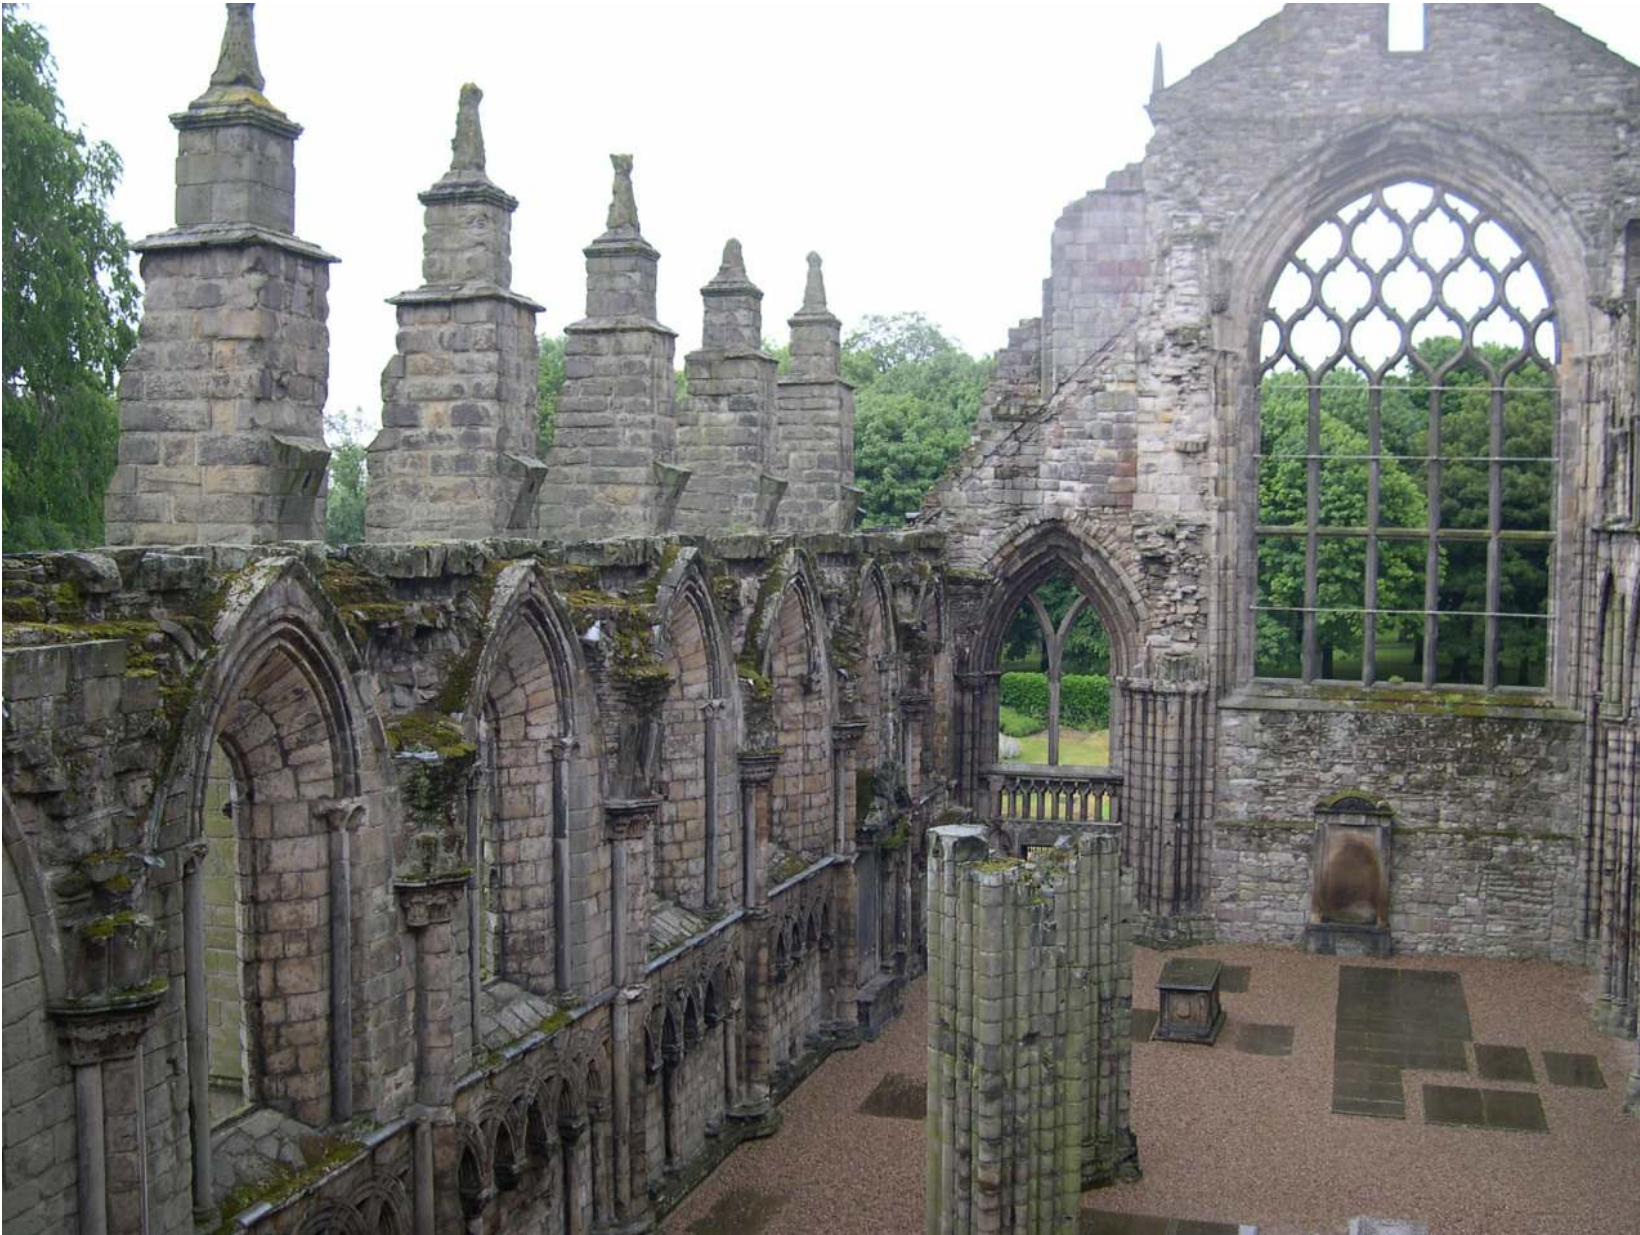
Collapse in 1768: excessive load placed on roof

- the walls and pillars of the church are two to three inches (50 to 75mm or $1/70$ of transverse aisle span) out of plumb at ten feet (3m) height to the North, i.e. possibly the S arcade moving inwards
- The East gable/ window inclines outwards to the East from 3 to 4 inches (75 to 100 mm) at ten feet high (3m) and the estimated the inclination would be 7-8" (175-200mm) at the top of the gable.
- Several voussoirs ("Coins of the Arches") have fallen down or were loose, many of the shafts of the piers were also loose and the walls had visibly bent.
- The whole building was giving clearly an impression it was slowly failing and he clearly attributed to the excessive load added over the walls, "a load the walls and pillars were never intended to carry".

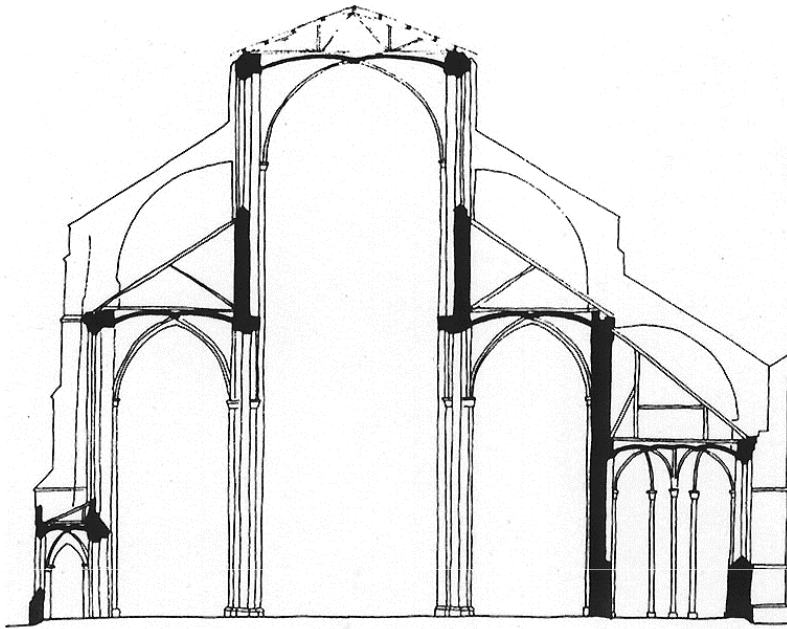
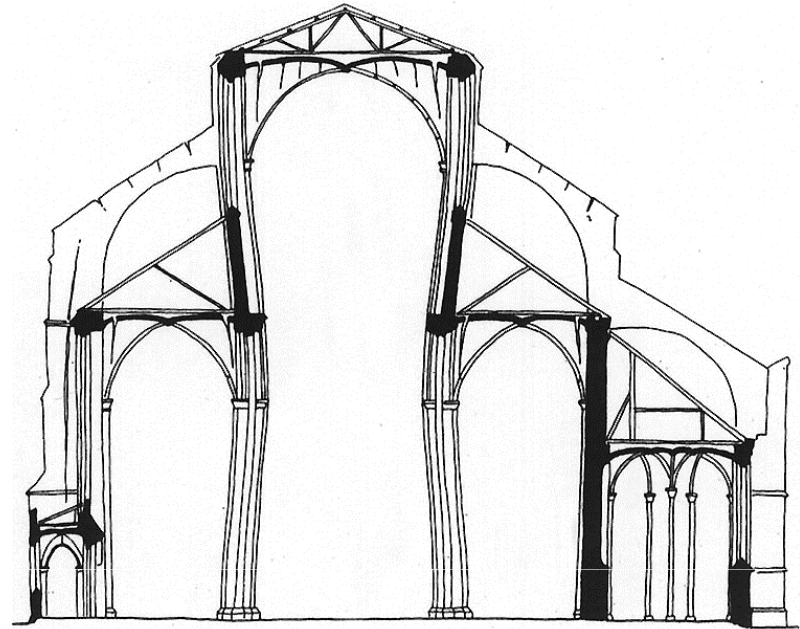
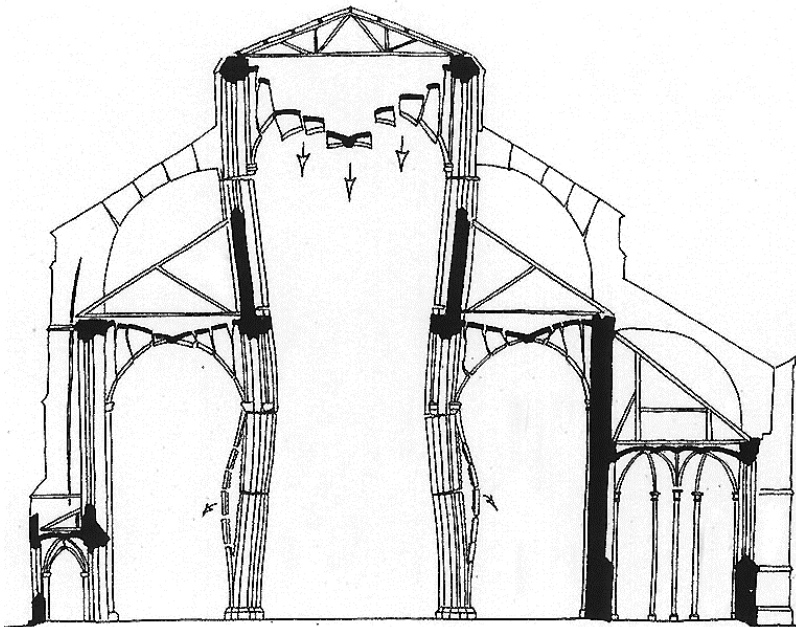
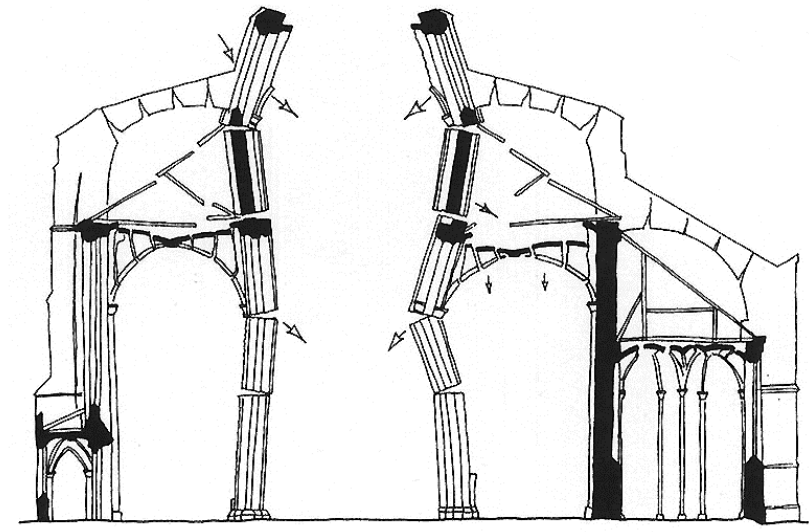
Experimental collapse at 31mm (1/30 of span)

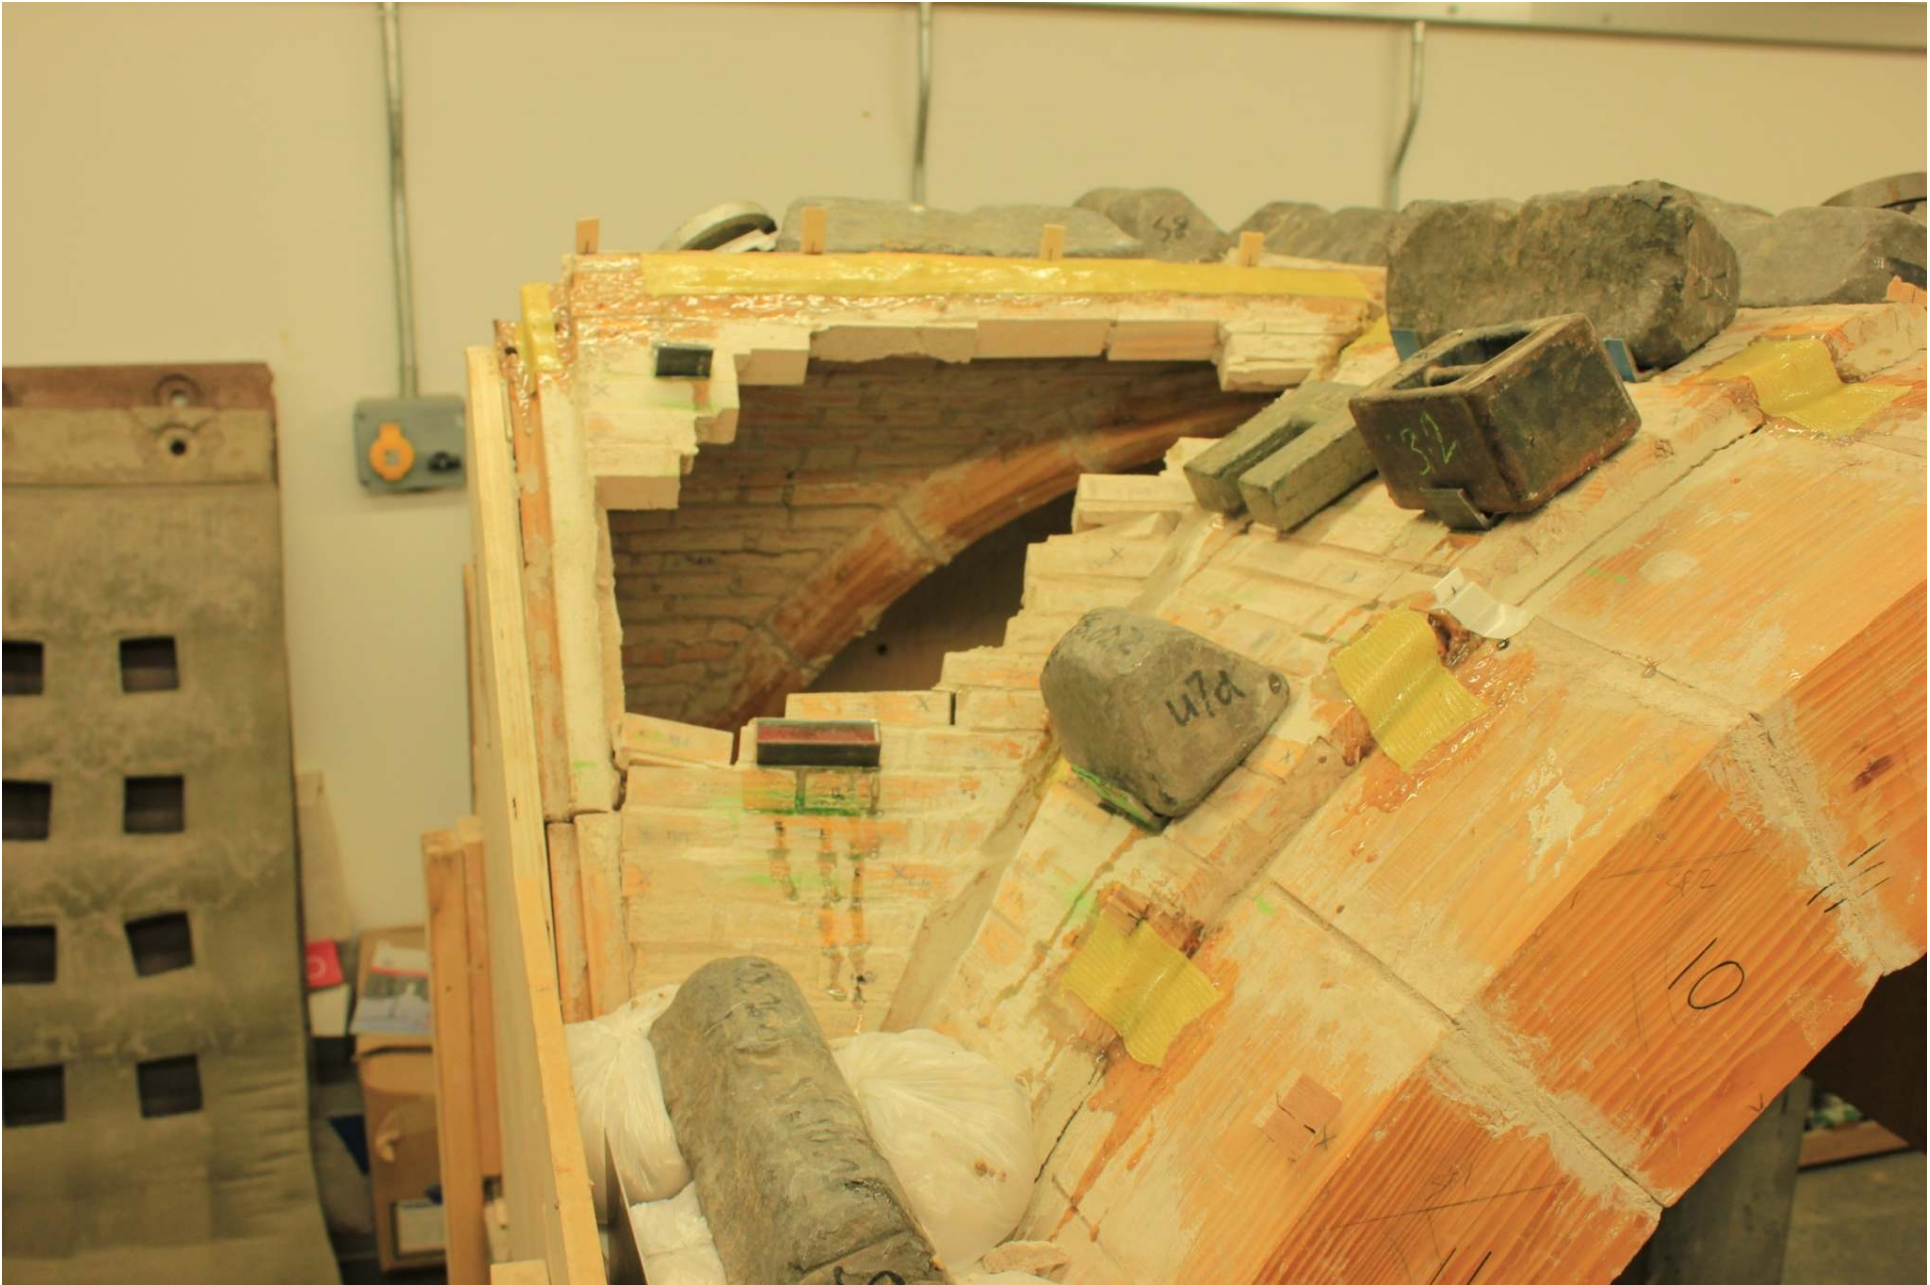
Substitute timber truss with stone walls, @600mm

L	s	d		Cost %
To taking off all the Old Roof and clearing of the Rubbish of the Tops of the Pends so as to get a clear foundation for the Stone Walls that is to carry the hewn Stone Roof					4%
and for supporting the Stone Roof	35				
To 54 Rood 18 yards of Rubble Building at £5 .. 3 p Rood	280	13	6	Ok	28%
To 12060 Feet of Hewn Stone contain'd in the Main Roof and Isles adjoining to (it)				Ok	40%
at 8d per foot	402				
To laying the whole Church with pavement Measuring 7500 feet at 6d per foot	187	10		ok	19
To levelling the floor of the Church and furnishing dead sand for laying the pavement of (Ditto)	10				1
To furnishing pan Cratch for jointing and laying the whole of the hewn stone of the Roofs	20				2
To pointing the whole of the Ashler round the Outside of the Church & Steeple with Pan-cratch and Harling the Rubble Building where there is no Ashler; the Measure being 1750 Yards at 6d per yard	43	15			4

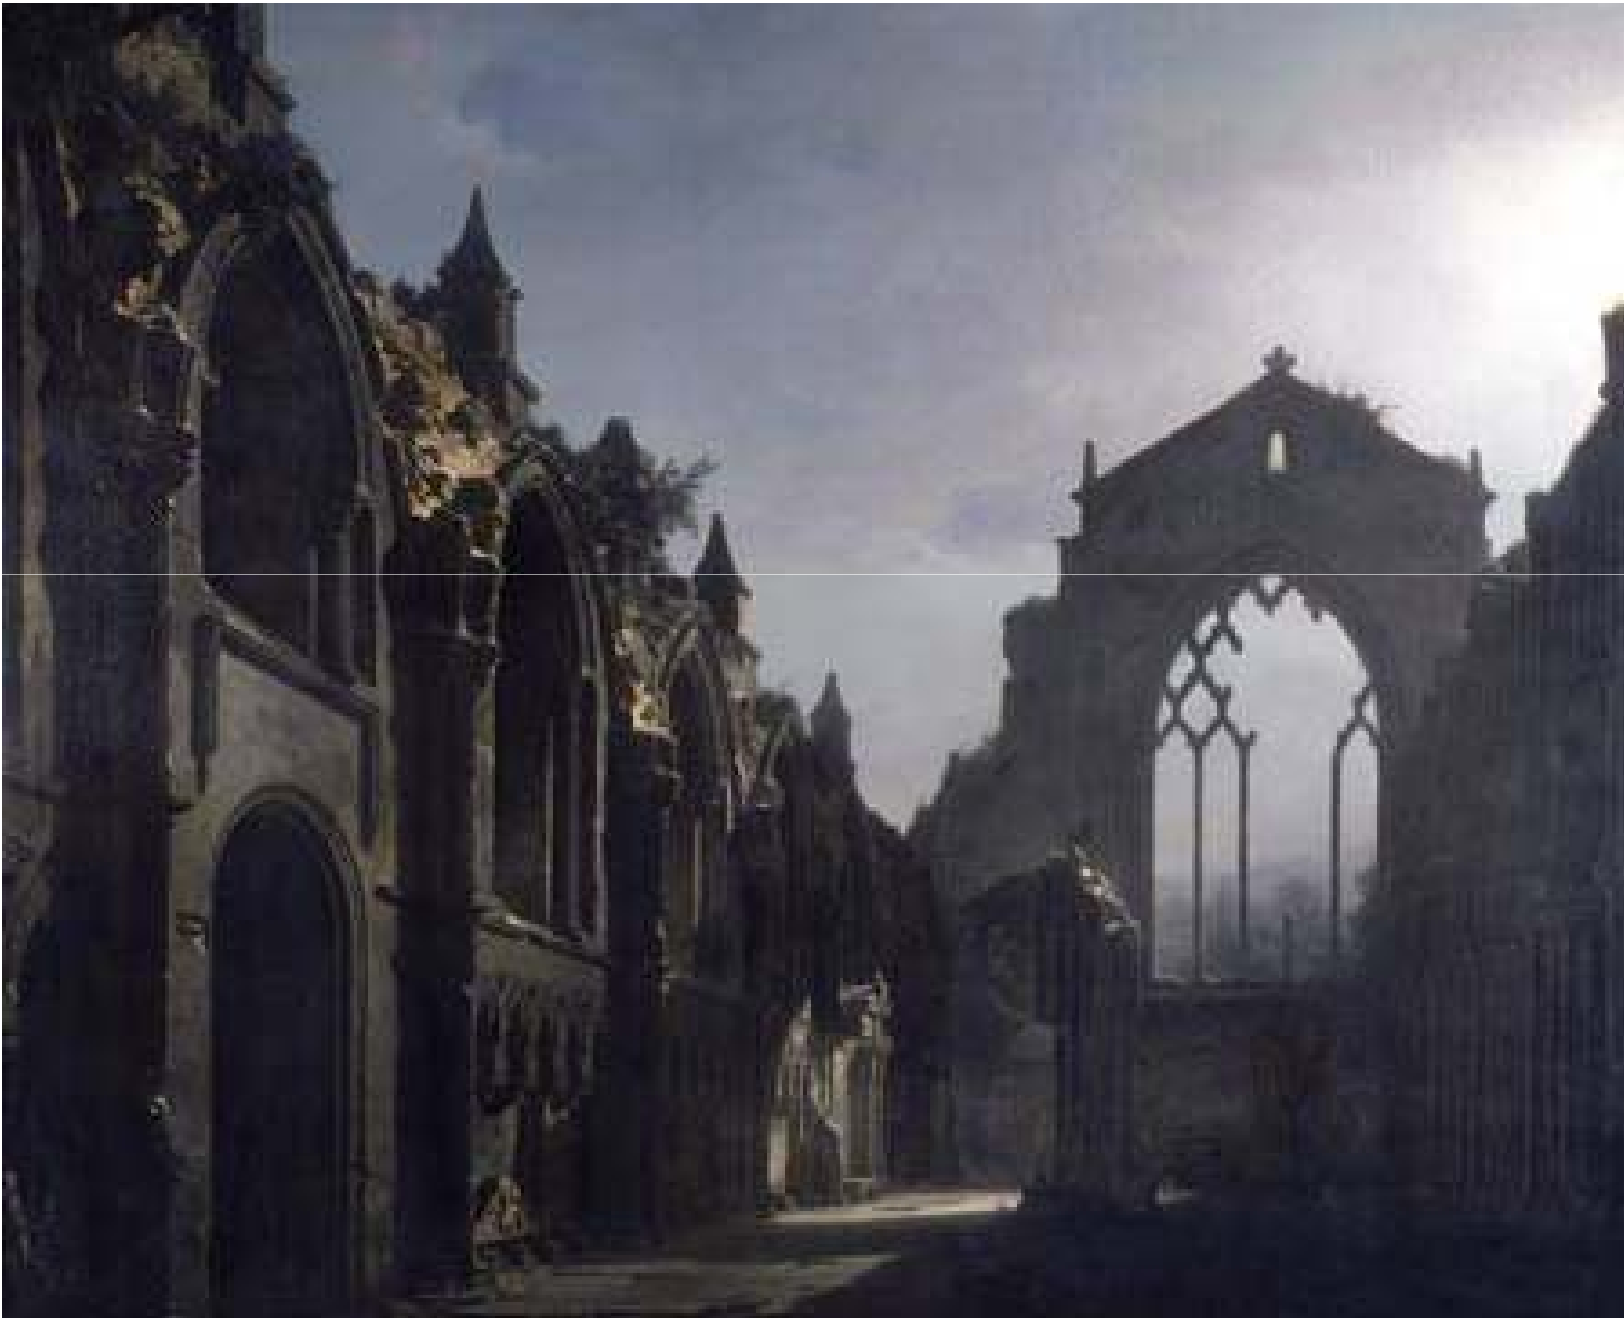
Reconstruction proposal, G Graham & Pugin 1834

PROPOSAL TO RESTORE HOLYROOD ABBEY

GILLESPIE GRAHAM & PUGIN 1836

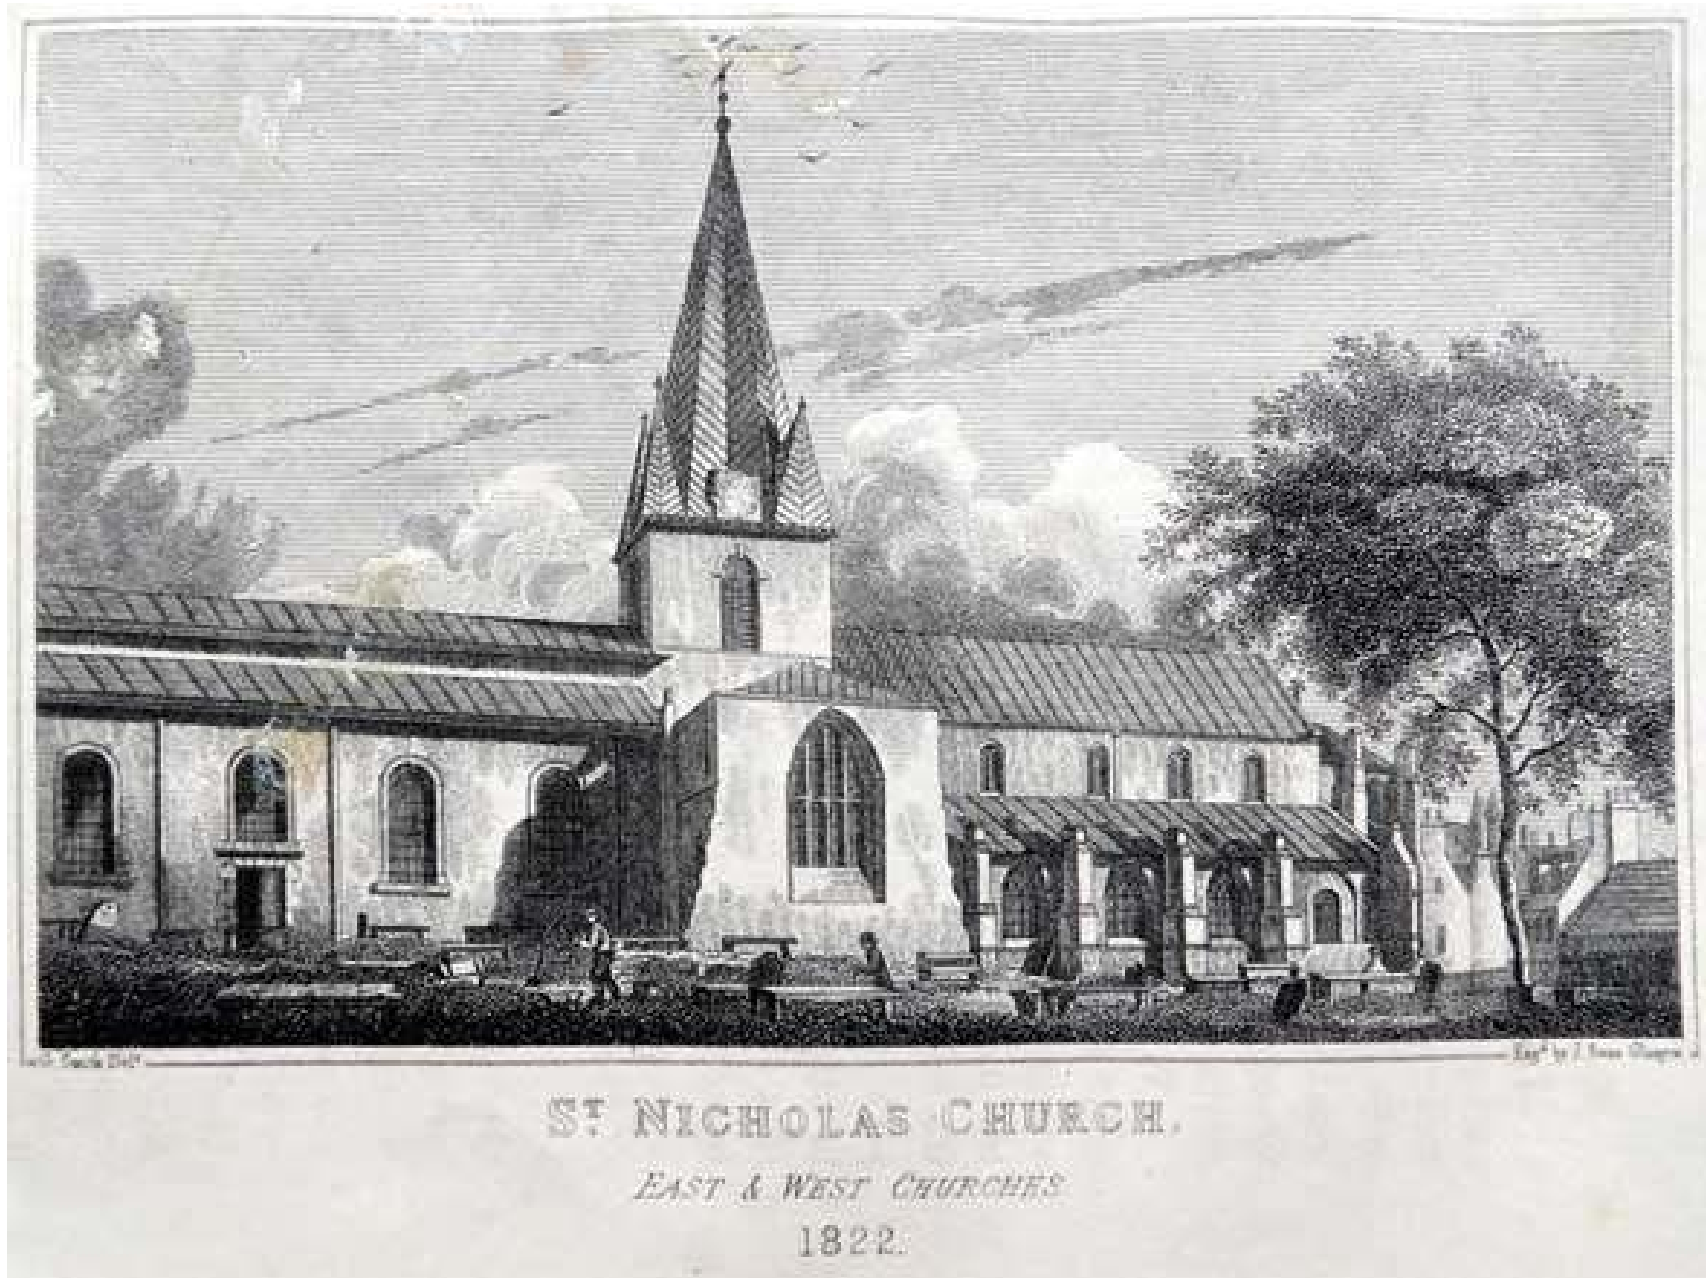
James Gibbs at West (Auld) Kirk, 1755

- Two parts for quite a period, 1596-1980
- Many reconstructions on the same site? What carries the memory of the form? Archaeology shows that footprint of foundations was the base for all phases.
- Gibbs could have been inspired by the venerable ruins of St. Machar's (1688) for the interior,- a too robust version of his style?
- Simpson does not follow Gibbs' arcade interior : restores Gothic concept (externally) but with Presbyterian interior
- Sequence reminiscent of Gothic cathedrals

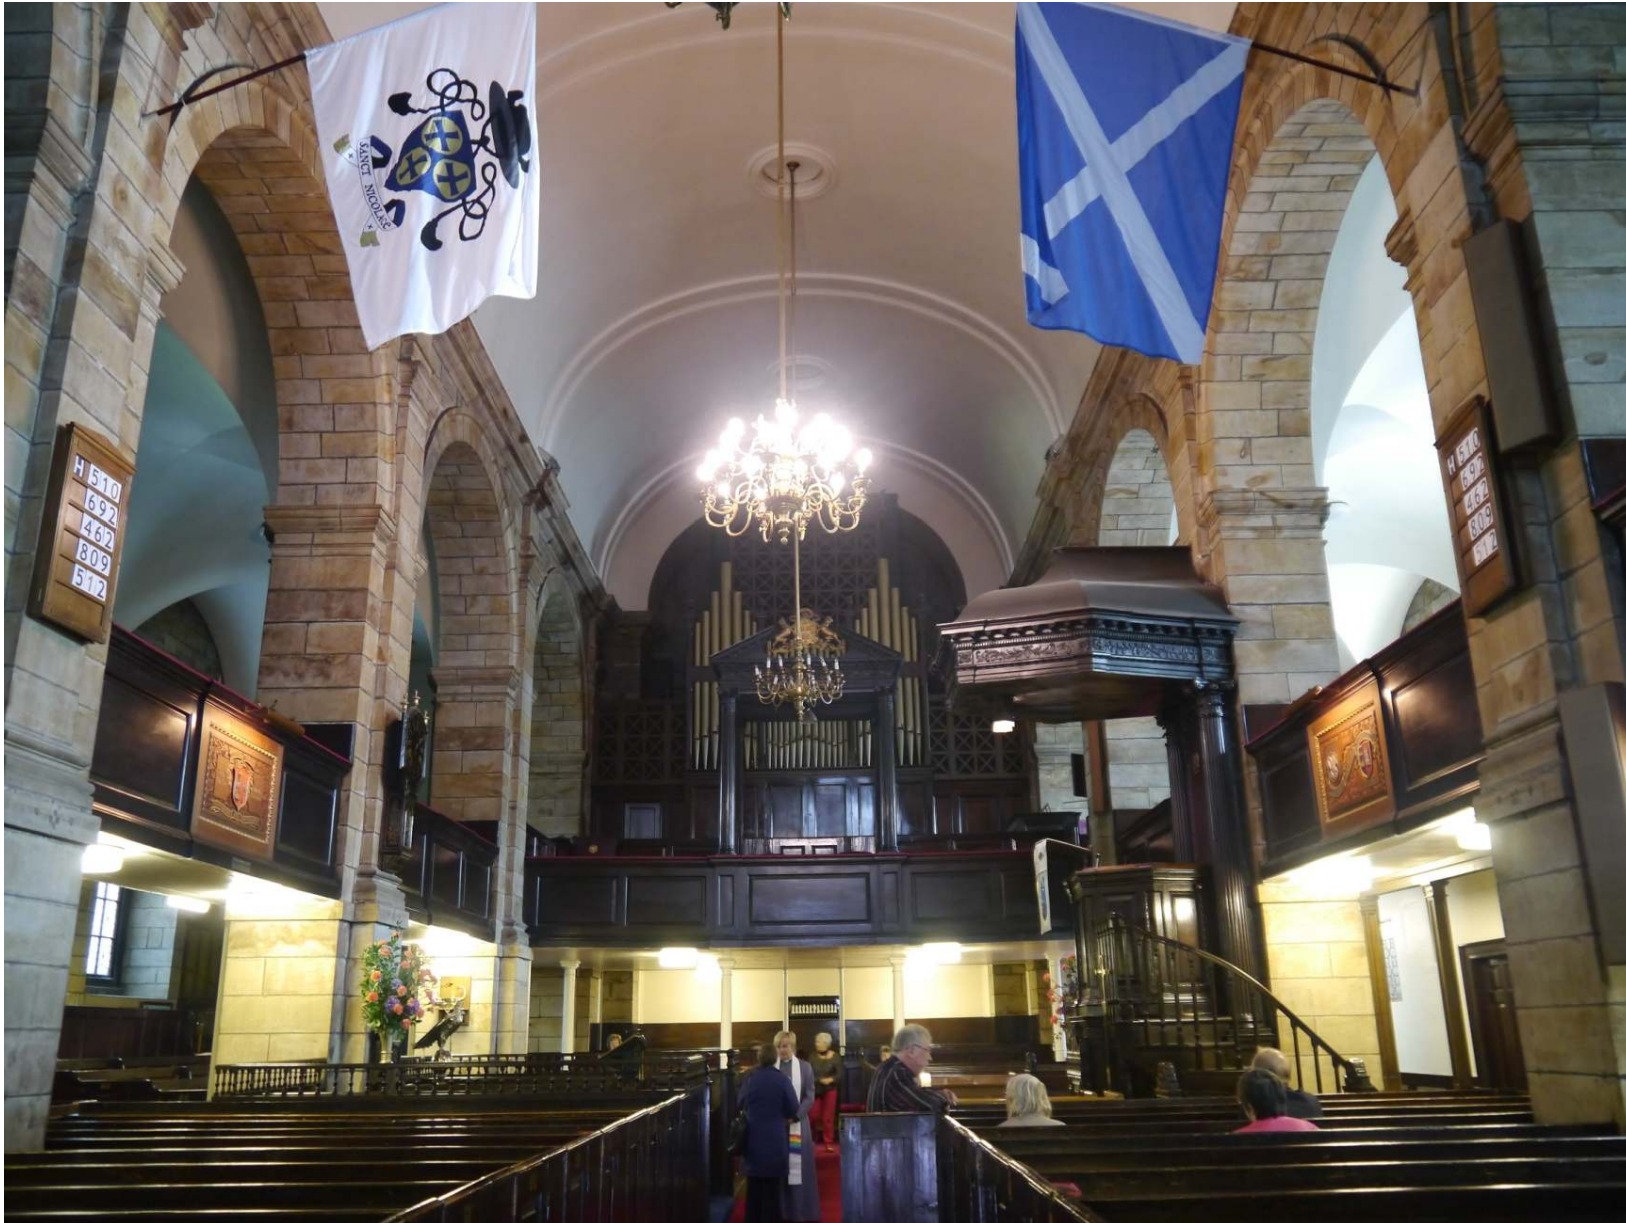
East (New) Kirk, reconstruction in 1874 of Simpson's plan (1837)

- 1477-1520: Expansion of original church
- 1596: new stone screen post-reformation. Nave is the Auld or West Kirk, Choir was the New or East Kirk
- 1732: Nave (Auld Kirk) unsafe and was closed (abandoned?), report by W Adam
- 1742 collapse (Nave?)
- 1751: Old Church demolished, after end of Jacobite rebellion
- 1755: West (Old) Church was rebuilt (James Gibbs, +1754)
- 1835; mediaeval choir [East Kirk] demolished; replaced in 1837 by Archibald Simpson
- 1874: fire; faithful reconstruction of Choir (East Kirk) as 1837 form (J&W Smith)
- 1980: East congregation was united with the West

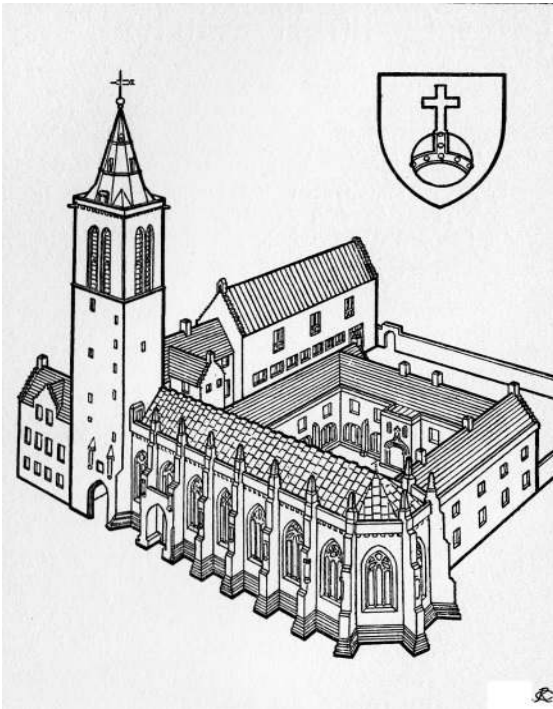
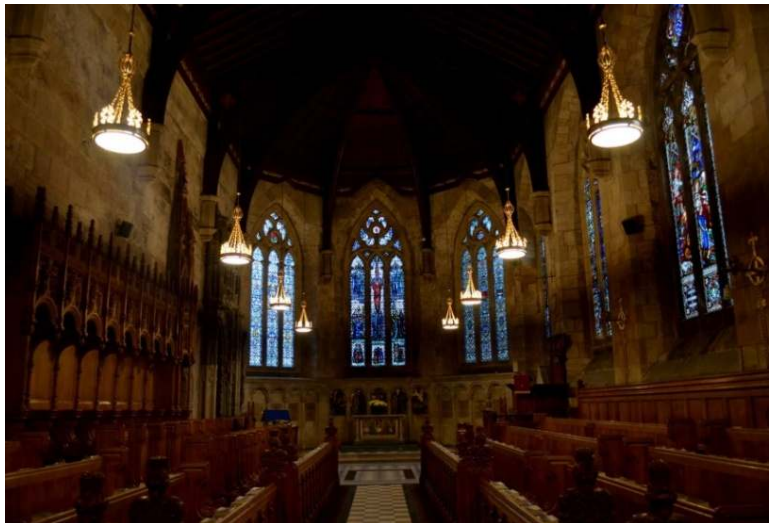
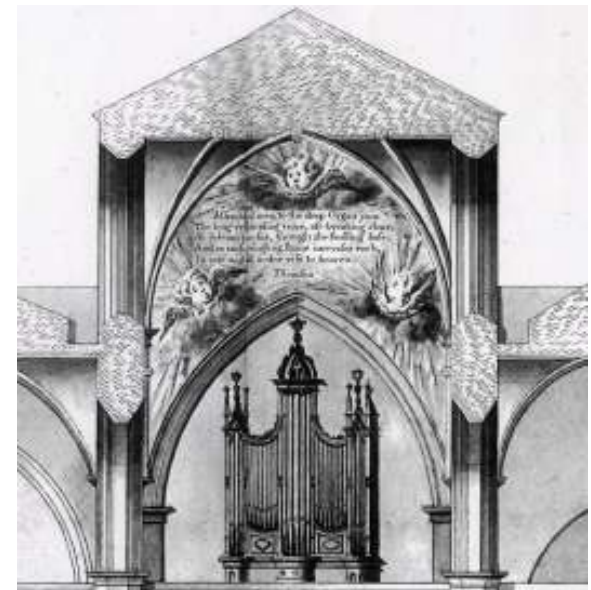
St. Salvator, St. Andrews, 1773

- Founded in 1450
- Stone barrel vault, spanning 24ft (7.3m) , possibly the biggest span among the 15C collegiate churches? (Holyrood = 8.1m)
- Possible inspiration to John Douglas for a flagstone roof for Holyrood Abbey , as he was building student residences in 1754
- Deliberate collapse in 1773 on the advice of James Craig

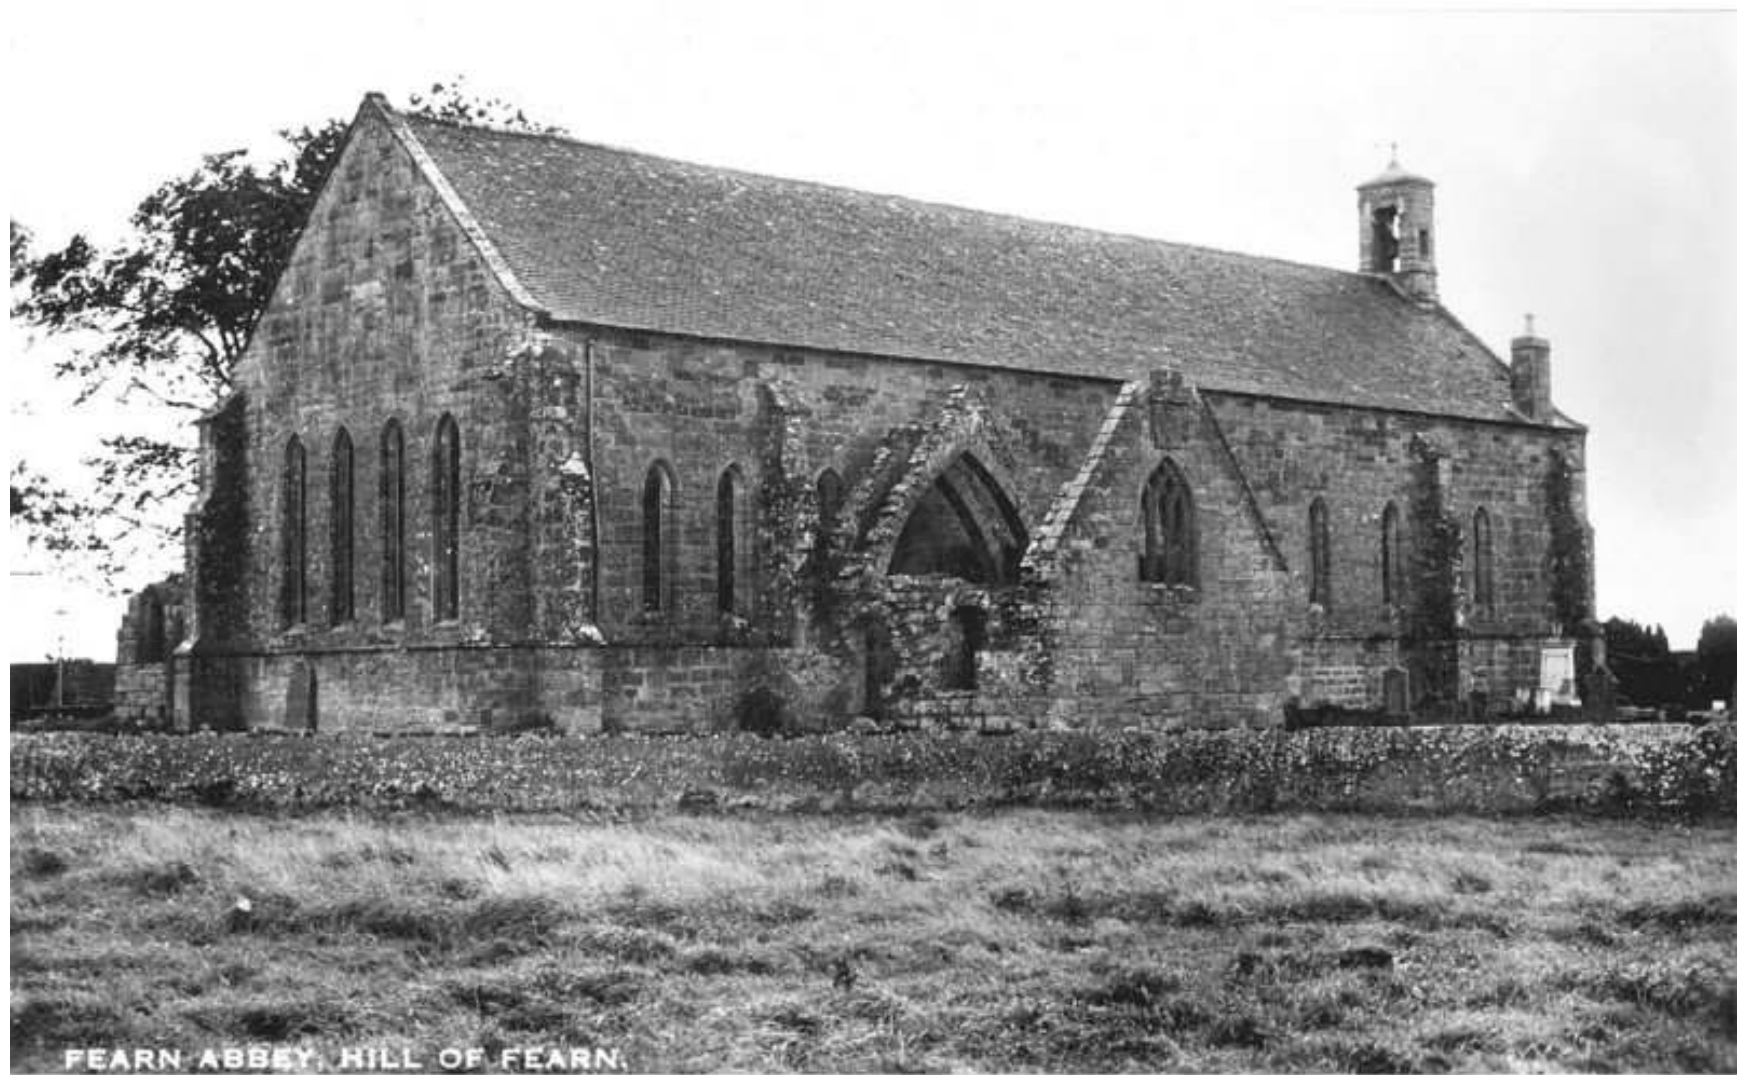
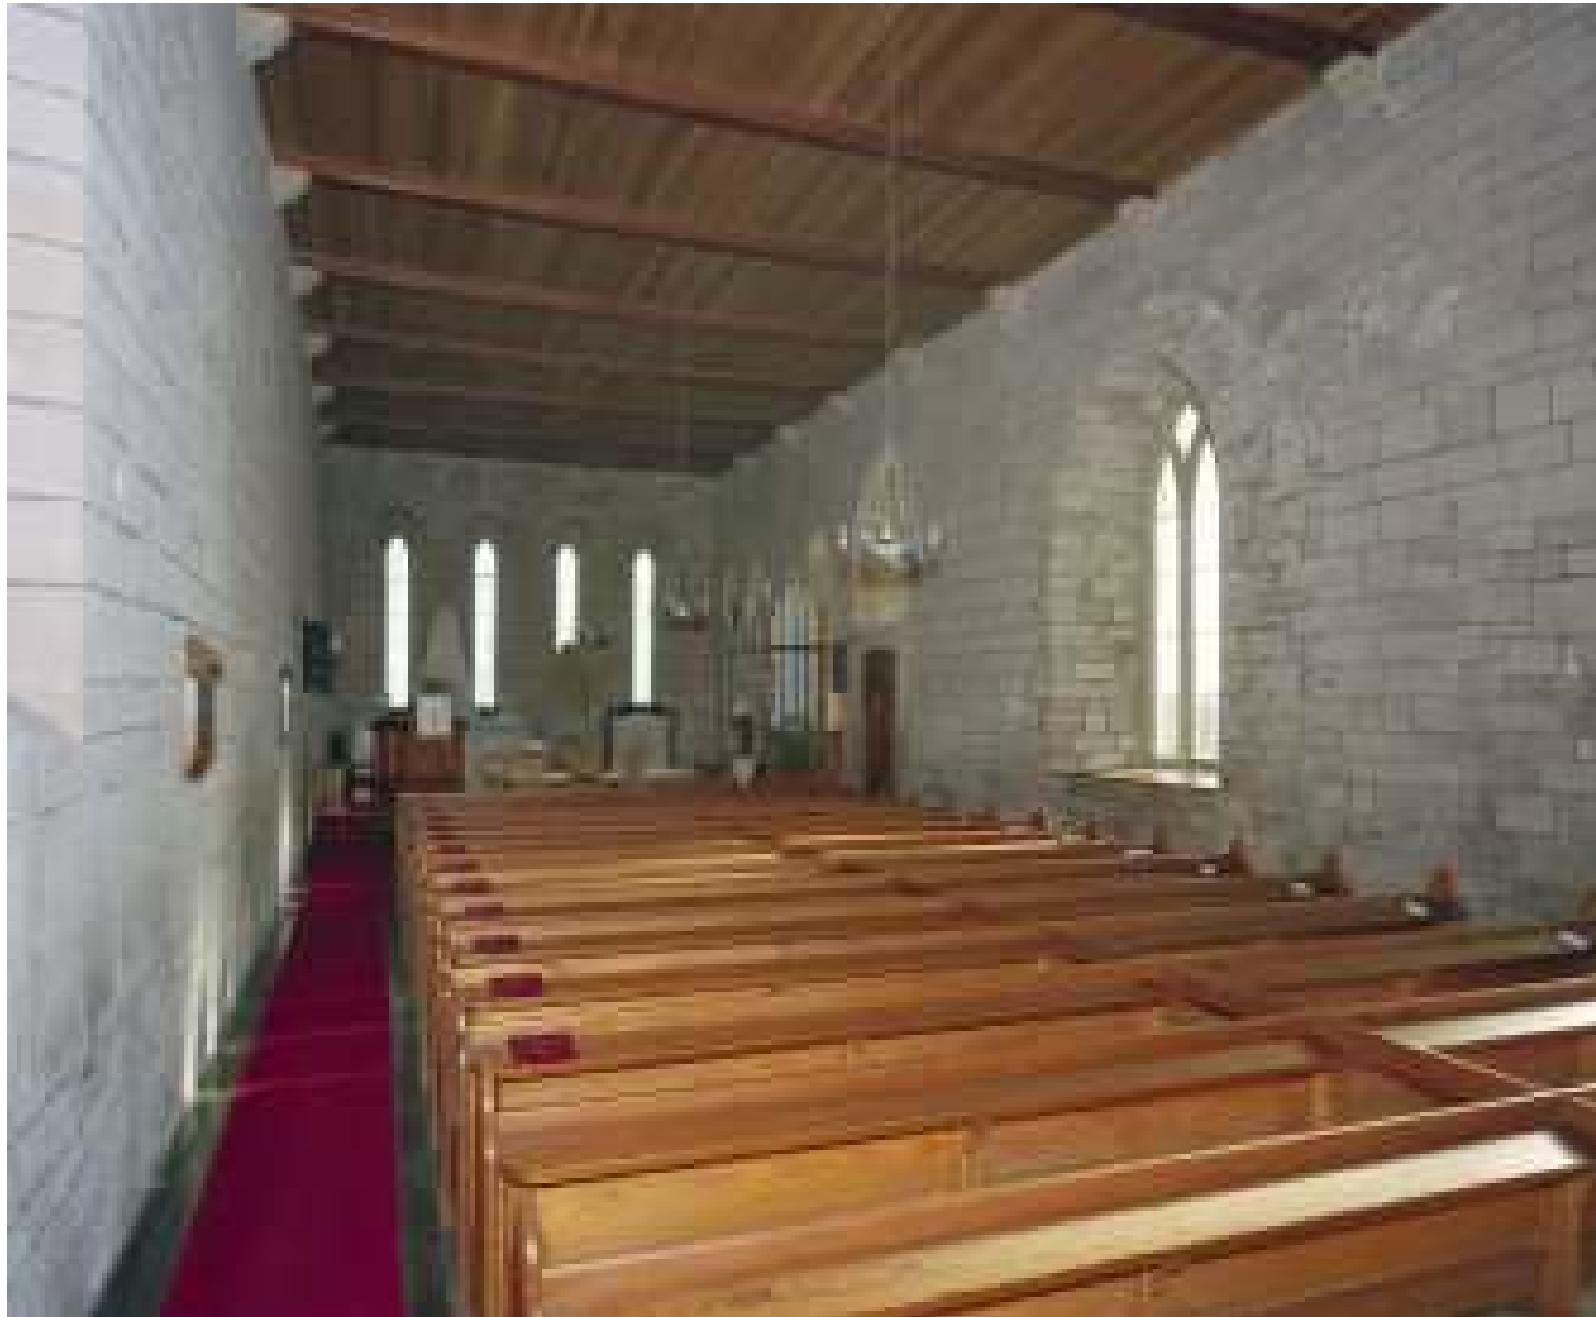
Fearn Abbey, 1742

- Peculiar succession of reconstructions that highlighted the parishioners love for their antique church
- Sunday 10 October 1742: church was struck by lightning during a service and the stone-flagged roof collapsed on the congregation, killing as many as 50.
- The Minister insisted a new church be built to the south, using stone from the remains of the dormitory, cloister and the west end.
- By 1771 the new church was in ruins...
- 1772 the original church was reconstructed, using stone from the replacement church - no sign of that church can be seen any more.

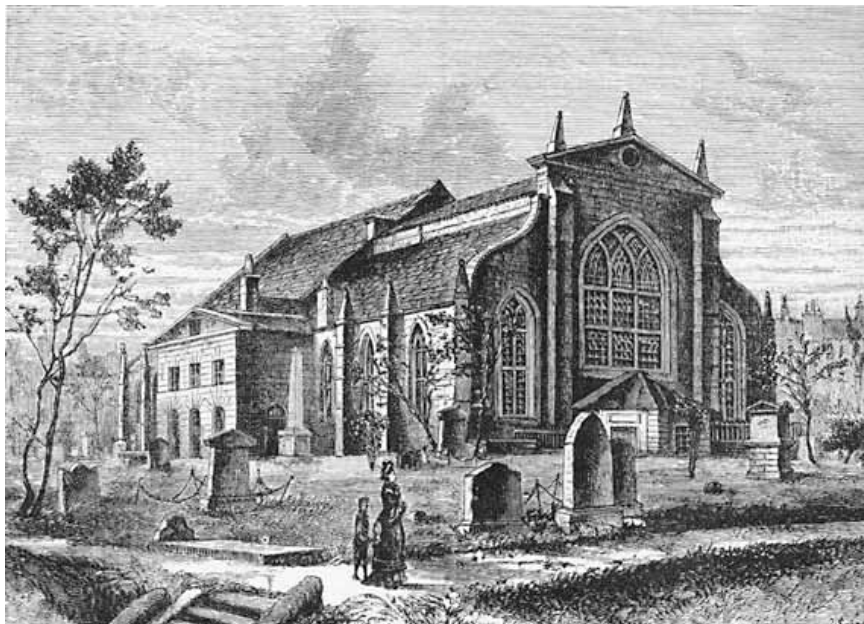
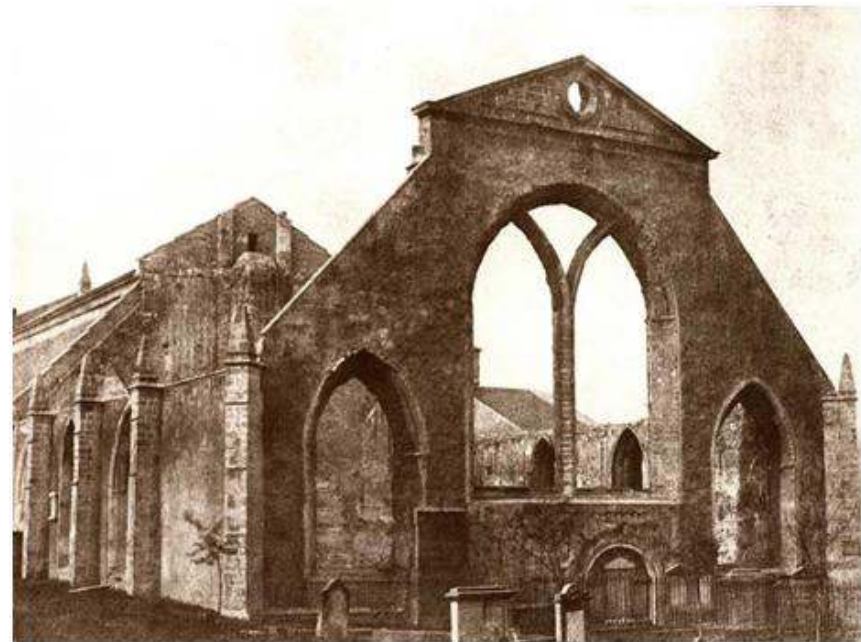
Greyfriars, Edinburgh

- 1602 simple six -bay building in late Gothic style with arcades.
- Explosion in 1718 - west end .
- A new west wall, two bays into the church, and a new church was added (two more bays)
- Porch on N side in 1721: access to both churches.
- Fire in 1845 : over many years, the original roof and arcades were removed to add a new, single-span roof
